The once and future 2'
and other observations from a restorer's notebook

by Keith Williams

St James Lutheran
Logansport, IN

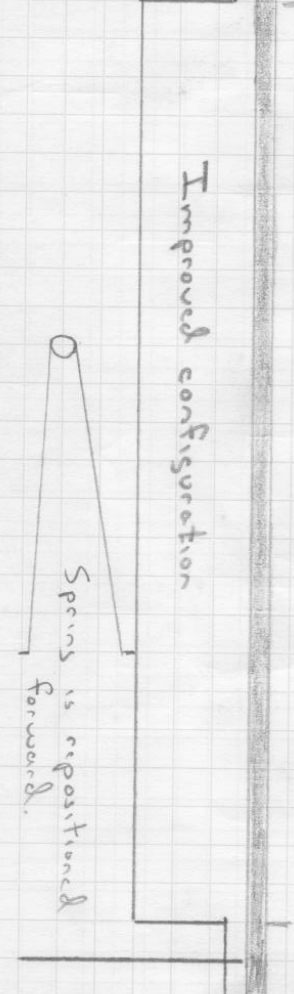
trackers. The Pedal windchests received new plywood top tables. Great, Swell and Pedal toeboards were modified to allow the installation of plastic slider seals; new phenolic sliders were installed, and slider seal rings were installed on the windchest top tables. The Great windchest was “replicated.” The new windchest was made to the original dimensions and reused the original pallets. However, the pallet springs for the extremely long (14-1/2”) pallets were relocated to the center of the pallet from their original location. The pallets had almost certainly originally been glued down at the tail, but in the reconstruction they were not. The result was a windchest extremely prone to ciphers. Previous attempts to solve this problem included replacement of the felt & leather pallet covering with leather backed with foam!

Felt/leather
extends beyond
tail of pallet
& is glued into
place.

Original configuration

Spring is positioned
well to front of center

thin felt/leather
Front of pallet X-pin
position side to side
by guide pins

End of pallet
notched

Present configuration

Spring is positioned
at center point

thick felt/leather
End of pallet
notched and
slotted.
← guide pin

Eventually, Buzard Pipe Organ Builders was able to return the pallet springs to their original location, and the pallets are now retained at the tail by a small spring, which has eliminated the persistent ciphering. Future plans call for the reinstallation of wooden trackers and squares to return the playing action to its original condition (eliminating the “sponginess” endemic to aluminum trackers installed in this fashion.)

Slot to be
cut into
end of
pallet

Improved configuration

coil spring
→
Steel ring →

Spring is repositioned
forward.
